Analysis of the 2007 Interstate-35 Bridge Collapse in Minneapolis, MN

Civil Engineering and Architecture

Isabel Kosic

12/4/14

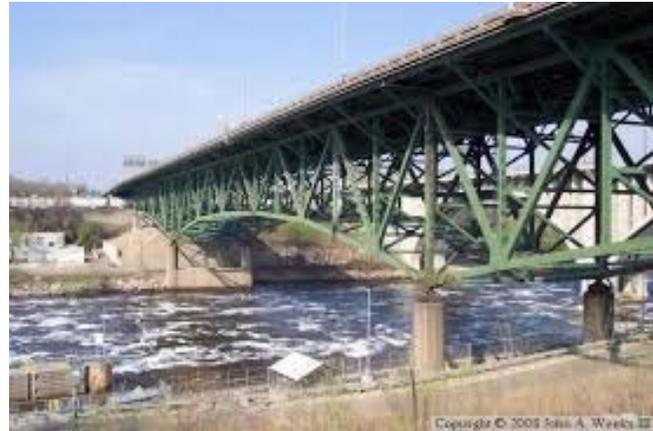
At 6:05 p.m. CDT on Wednesday, August 1, 2007, during rush hour traffic, the central span of the I-35 Mississippi River Bridge (pictured to the right) suddenly collapsed into the river below it, followed by the adjoining spans. 13 people were killed, 145

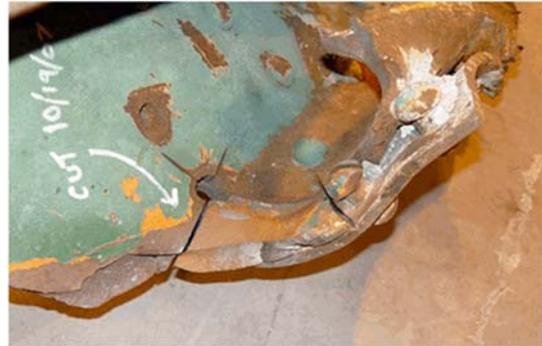
3. Steel gusset plates: The steel gusset plates were undersized and inadequate to support the load. The gusset plates at eight different joint locations in the main center span were fractured (see picture on right).

Some gusset plates were bowed, and others were corroded from rust and other reasons. In December, 2006, a steel reinforcement project was planned for the bridge. However, it was revealed that

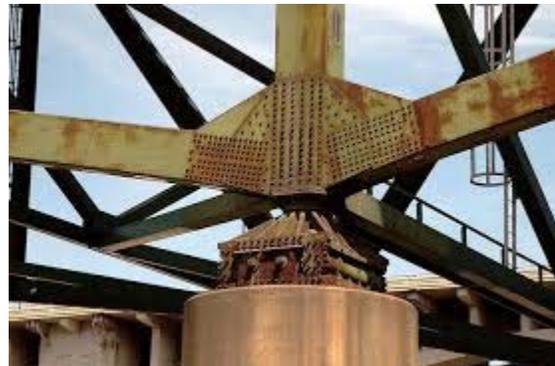
4. Bearings: The roller bearings for the bridge (see picture below) were severely corroded, and didn't really allow the bridge to expand and contract a lot during different weather conditions.

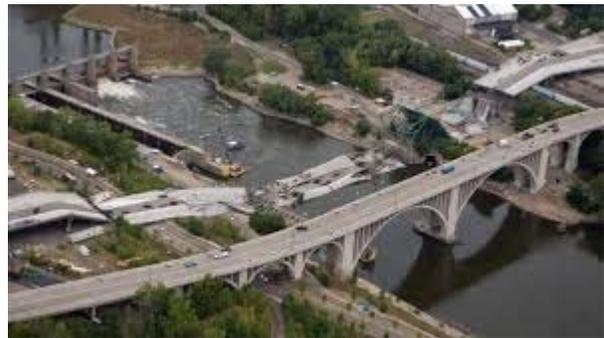
Of course after the bridge collapsed (pictured to the right), fingers pointed at who was to blame for this fatal accident. MnDOT (Minnesota Department of Transportation) was responsible for the inspection and maintenance

of the bridge. I believe that they were partially responsible for the collapse of the bridge. MnDOT did not adequately document inspection report findings, such as the bowed steel gussets. The action taken by MnDOT to correct the bridge did not improve the “poor” rating of the bridge’s structure. They did not conduct an analysis in response to the bridge’s deteriorating condition, and they did not effectively follow through on the advice of their experts on the condition of the bridge. I believe they did not do their job properly and thoroughly.

If I was to go back in time to prevent the collapse of this bridge, I would make sure that the steel gussets are strong enough and thick enough before construction. I would also increase the amount of redundancy in the bridge structure. I would forbid the addition of traffic lanes on the bridge, as this would increase the live load. I would conduct thorough inspections of the structure of the bridge at least once or twice a year.
