STRUCTURAL FAILURES

Hyatt Regency Skywalk Collapse Remembered

By Randall P. Bernhardt, P.E., S.E.

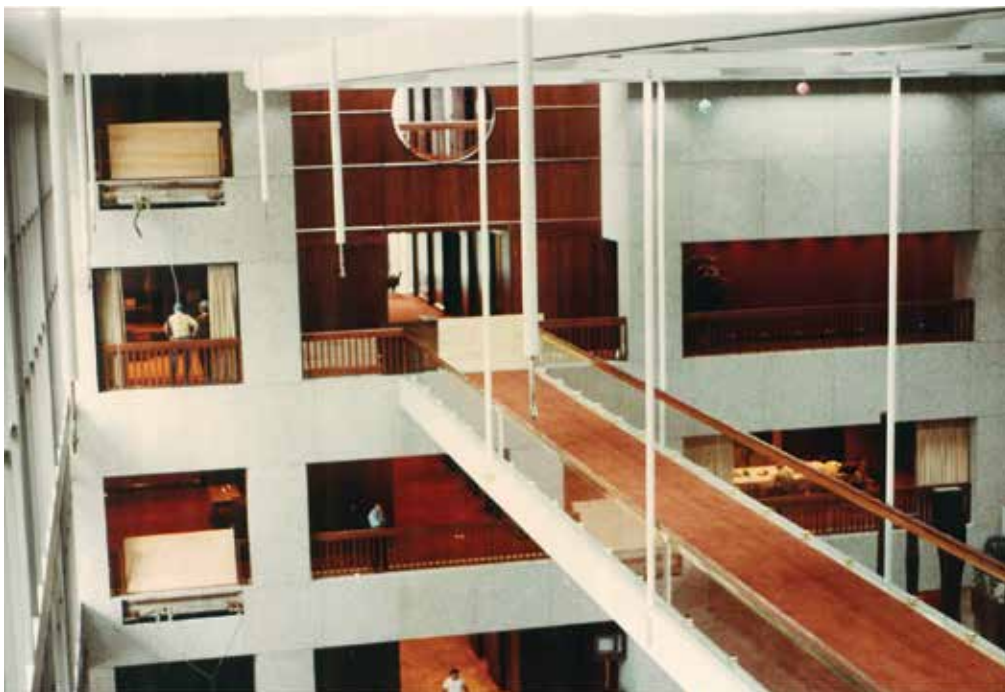
In the final configuration, the fourth-floor walkway was positioned directly above the second-floor walkway. The third-floor walkway was offset from the other two (*Figure 1*). The distance that the walkways spanned from the tower structure to the conference center was approximately 120 feet. The 120-foot length was split into four equal spans of approximately 30 feet each, using two (2) W16x26 longitudinal stringers per walkway. The ends of the walkways were supported by the tower and conference center structures, but each interior span support consisted of a built-up box beam suspended from the roof structure by two steel hanger rods. The box beams consisted of two MC8x8.5 channels welded toe to toe. The hanger rods were 1¼-inch diameter steel with a yield stress of 36 kips per square inch (ksi) (Marshall et al. 1982). The roughly 8-foot wide walkway was comprised of 3½-inch thick lightweight concrete on 1½-inch steel form deck that spanned longitudinally between W8x10 floor beams (*Figure 2, page 26*).

Figure 1. After the event; the fourth-floor hanger rods remain next to the intact third-floor walkway.

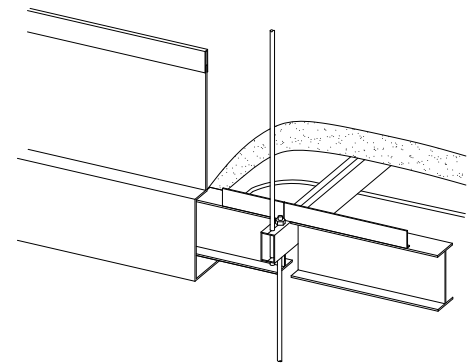
Figure 3. The perspective of the critical connection showing the double rod configuration. (Marshall, R.D., et al, 1982. Page 30.)

- 3) The project manager conditionally approved a change request from the fabricator to use a double rod configuration in lieu of a single continuous rod (Figure 3). This essentially doubled the load on the rod-to-box-beam connection at the fourth-floor walkway. The structural engineering manager requested it be submitted as a formal change request, delaying the final review until a later date. The fabricator did not formally submit the change from one continuous to two offset rods as requested by the structural engineer.

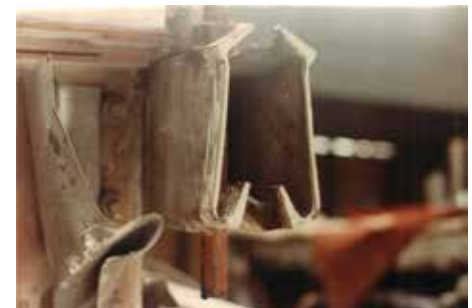
At approximately 7:05 pm on July 17, during the Tea Dance, with less than 10 people on the fourth-floor walkway and less than 60 people on the second-floor walkway, the bottom flange weld connecting the two MC8x8.5 toes ruptured. The rupture was caused by the force of the fourth-floor walkway-to-roof hanger rod nut on the bottom surface of the box beam. Before the rupture, the welded channel flanges acted continuously between the webs. After the rupture, the flanges were cantilevered. They rotated upward from yielding in the web which allowed the bolt and nut to slip through the hole (Figure 4). The impact from the bolt and nut on the upper flange of the box caused failure of the upper flange, with the bolt and nut slipping through the hole in an instant at that point. The fourth-floor walkway became disconnected from the roof support, and both walkways collapsed onto over one hundred people standing below (Figure 5) (Luth 2000).

Figure 4. Deformed box beam failed connection.

- 6) Poor quality of workmanship and materials did not contribute to the collapse.
- 7) The critical portion of the structure, and where the collapse initiated, was at the fourth-floor hanger rod to fourth-floor box beam connection. This connection had a tested ultimate capacity of 18.6 kips, with a code-required load demand of 40.7 kips.

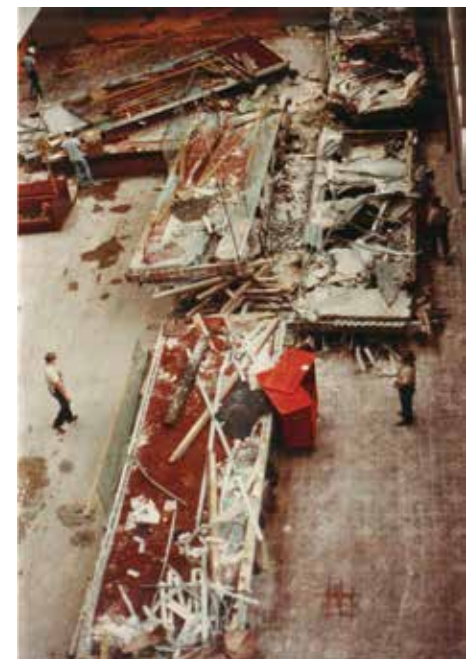
Figure 5. The collapsed second- and fourth-floor walkways on the floor of the atrium after the rescue operation.
