Falling Water Restoration

By: Sarah Johanson
Civil Engineering and Architecture
Sep 2014

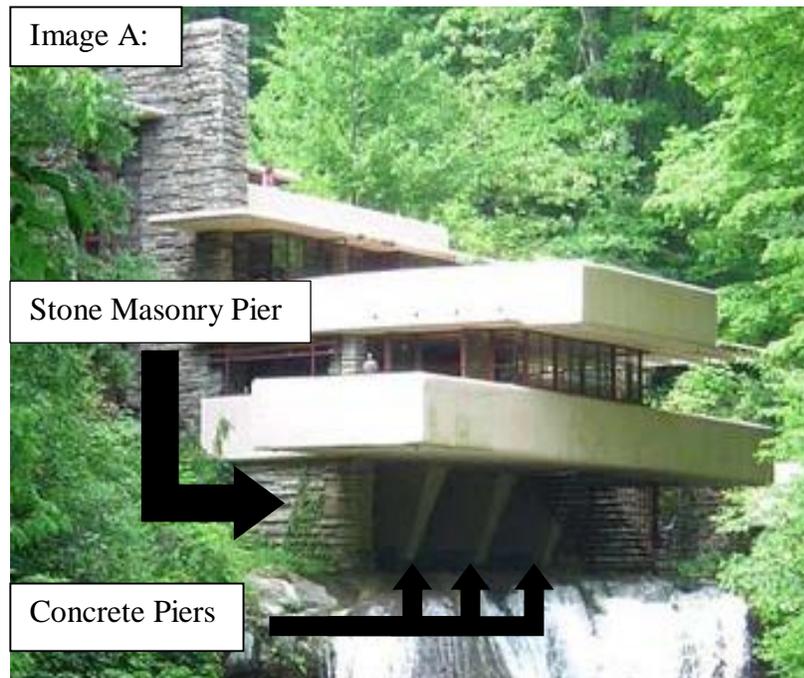
The basic foundation of Falling Water stands on four main piers (visible in image A.): three of which are made from reinforced concrete, while the fourth pier is made up of stone masonry mined from a nearby stone quarry that was reopened during construction. The first floor consists of four cantilevered beams, which project 15' from the piers into mid-air. The beams are supported by concrete joists which transfer the weight from the first floor to the beams. For

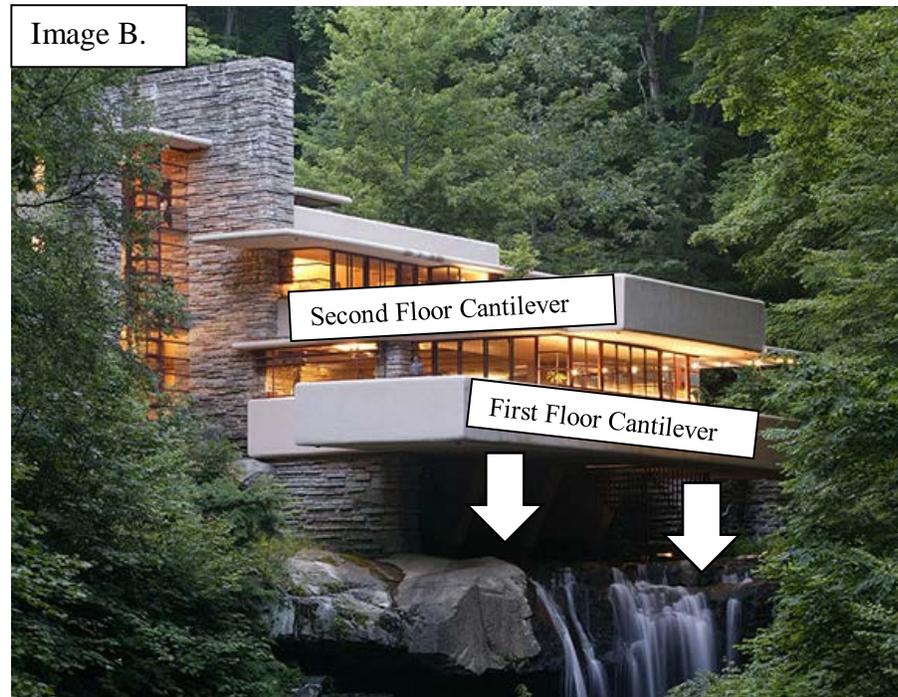
After the first floor was completed and the framework was removed, workers recorded a 1.75” deflection in the cantilever. Following the completion of the second cantilever, two large cracks appeared in the ceiling of the first floor; at this point it became obvious that there was a problem

with the structural design. In 1995, further examination of Falling Water showed a deflection of 7” in the first floor cantilever (the tilt can be seen in image B). The reasoning behind such a large deflection lies in the insufficient structural capacity of the cantilevered girders.

Because the girders did not have a sufficient amount of negative reinforcement steel, the existing steel reached its holding limit and began to expand; deflecting the first floor cantilever and threatening to collapse the building. Furthermore, during construction, it was believed that the second floor terrace acted independently, however, this was not the case; contradictory to beliefs, the second floor terrace transferred its weight to the edge of the first floor cantilever by means of the four steel window mullions. This extra weight to the edge of the cantilever added to the significant deflection of the first floor.

Following the major deflection discovery in 1995, the Western Pennsylvania Conservatory decided to take steps towards restoring Falling Water. While a permanent solution to the problem was being solved in 1997, temporary shoring was placed beneath the first floor to support the structure and prevent any further damage to the building. Finally, in 2002, Falling water was repaired permanently using post- tensioning.
