**CONDITION REPORT  
FOR  
LAWSON VALLEY ROAD  
BRIDGE OVER LAWSON CREEK**

**PREPARED FOR  
THE COUNTY OF SAN DIEGO  
DEPARTMENT OF PUBLIC WORKS  
AL-S03-303-01**

April 2002

**PREPARED BY**  
**BOYLE**  
ENGINEERING CORPORATION

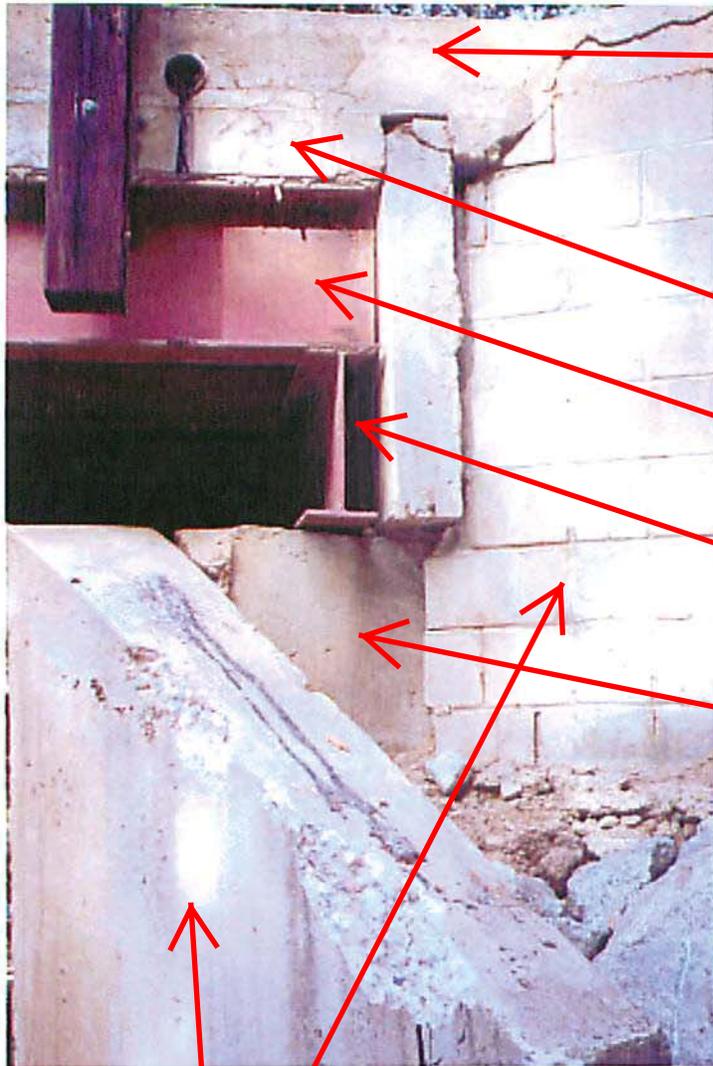
**S-5: Southeast Wing Wall and New Foundation**

This is just a 'curb' sticking up

Existing 7" thick concrete roadway decking

Decking is supported by steel girders running lengthwise

Steel girders are resting on 'cap beams' at each end of bridge

The cap beams rest on a concrete foundation at each end of bridge

These are called 'wing walls' in bridge terminology

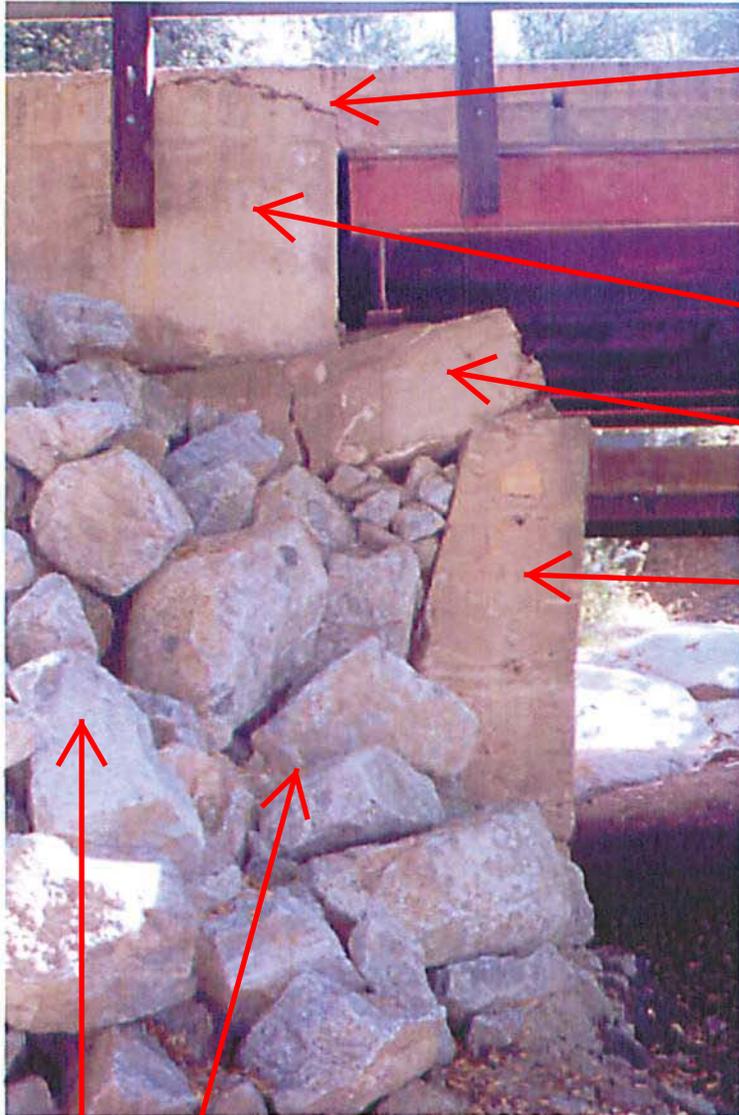
**S-7: Northeast Wing Wall and Old Abutment**

Big cracks not good

'Wing wall' settling (sinking)

Concrete footing sitting at a dangerous angle. This holds up the bridge!

Abutment wall tipping dangerously. Could lead to total collapse.

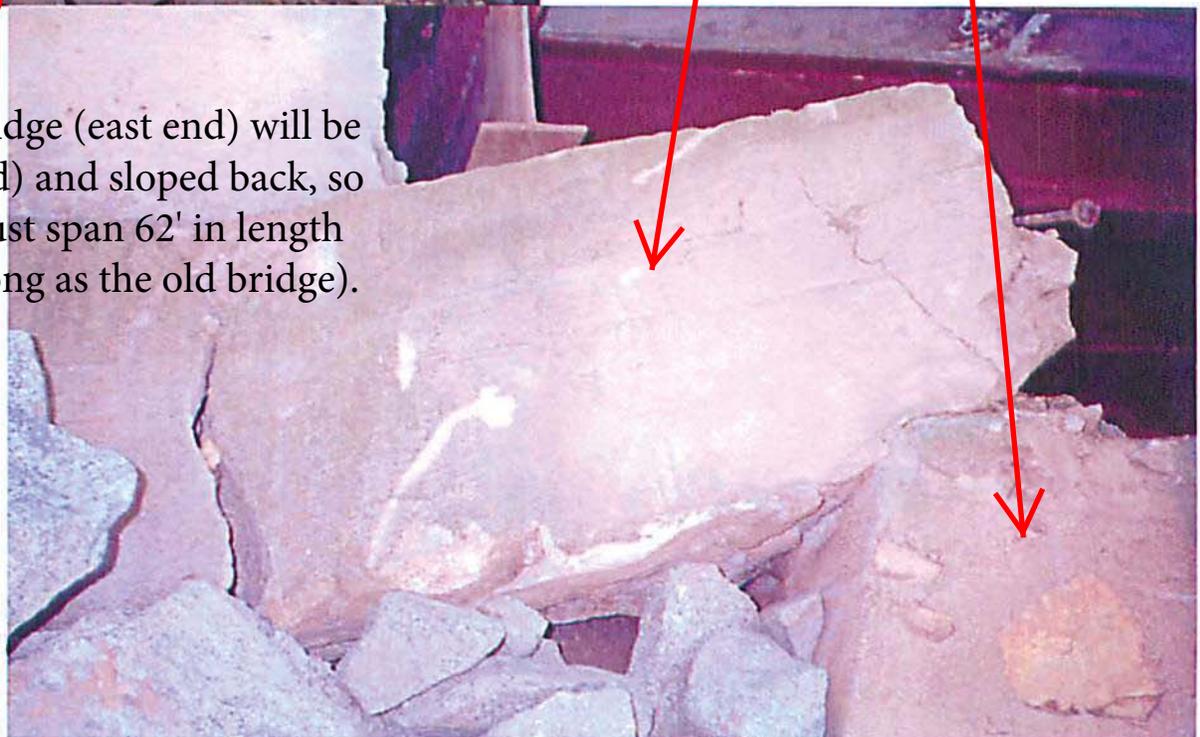
**S-8: Old Northeast Wing Wall Footing With Crack**

During the field review of the structure, it was determined the abutment cracking and rotations occurred at or before the time of the construction of the 1973 bridge structure. The crack in the old wing-wall footing was caused by the subsidence of the foundation soils of the 1973 bridge footing. The erosion of the riverbank soils along the wing walls has extended under the wing-walls reducing the support of the wing-walls and needs to be repaired.

Closeup of dangerous footing and abutment wall

This end of the bridge (east end) will be dug out (excavated) and sloped back, so the new bridge must span 62' in length (almost twice as long as the old bridge).

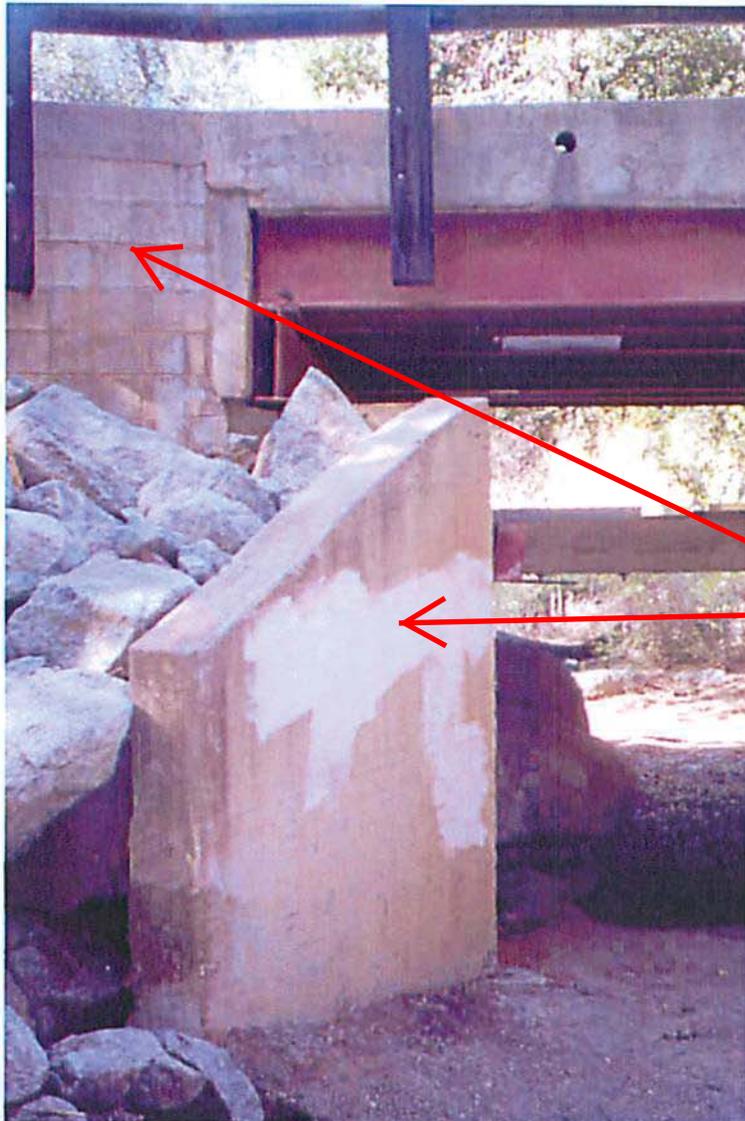
**S-9: Southwest Wing Walls**

Apparently the west end looks okay...

These are both 'wing walls' technically. The lower one is just the wing wall for the stream culvert.

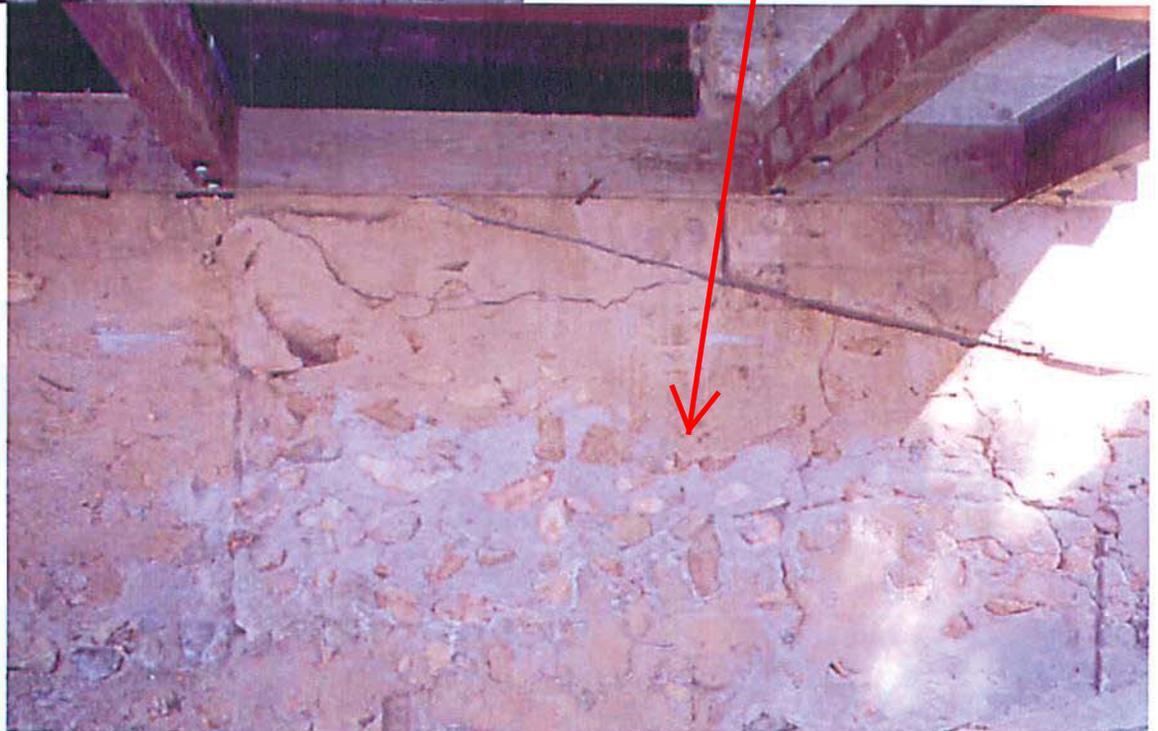
**S-10: Elevation of East Old Abutment Wall**

In our analysis of the structure, the original old abutment wall design was reviewed and it was determined the old abutment was significantly overloaded. The overturning safety factor of the old abutment is 1.05 compared to the required 2.0 safety factor value. The addition of the new timber bracing greatly enhanced the performance of the old abutment structure. The new timber bracing changed the design concept of the wall from a cantilever structure to a fixed-pinned structure. The braced old abutment wall system is now adequate for the desired HS20 loading. The bridge structure has operated in an overloaded foundation state ever since the construction in 1973. The good performance of the bridge over the years is probably due to the light volume of traffic and the limited amount of truck traffic.

This is the abutment wall that's tipping dangerously

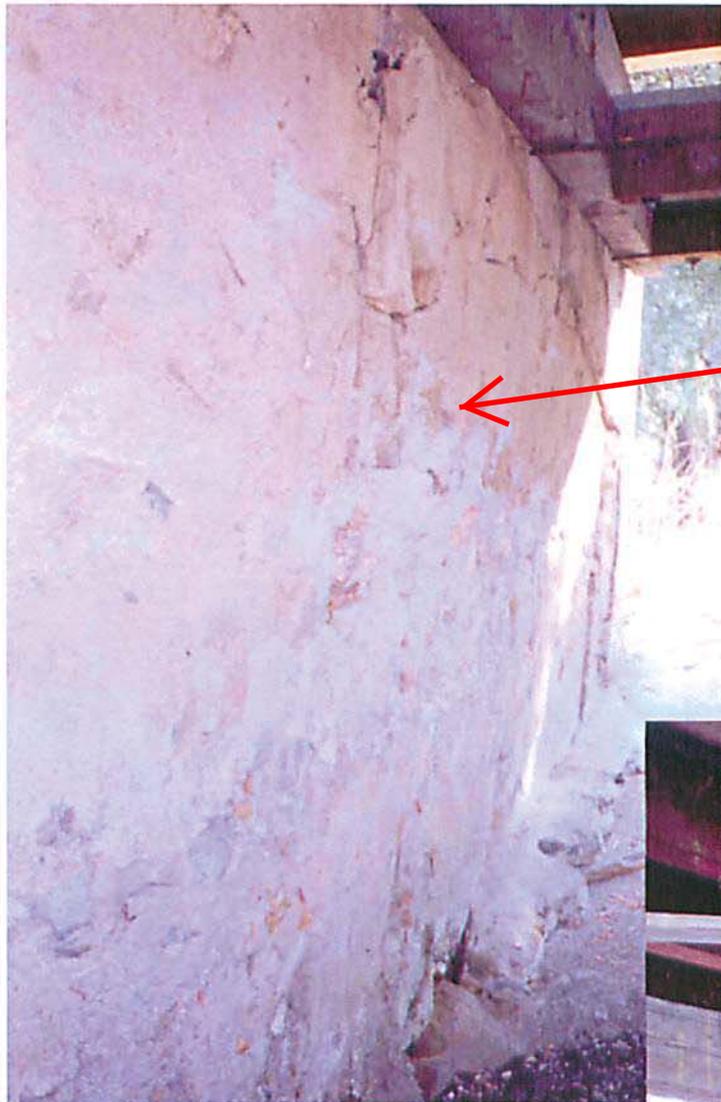
**S-11: Elevation of East Old Abutment Wall**

The 'leaning' abutment wall

Again, this is the temporary wood bracing that was added to prevent collapse
