Analysis of the 2007 Interstate-35 Bridge Collapse in Minneapolis, MN

Civil Engineering and Architecture

Isabel Kosic

12/4/14

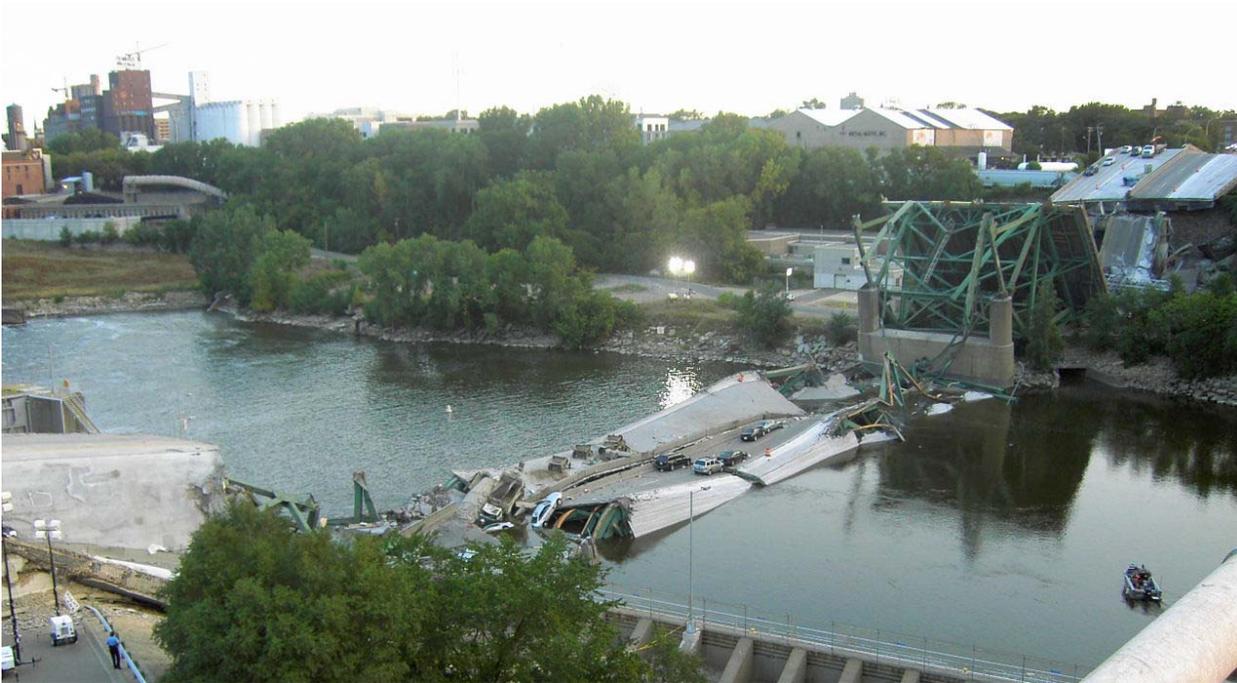
- Undersized steel gusset plate
 - The design calculations were not done correctly by the original design firm making it $\frac{1}{2}$ " instead of 1".
- Increased load on the bridge.
 - Bridge was reconfigured from 4 lanes to 8 lanes.
 - 500,000lbs (250 tons) of construction material piled on the bridge (Over the gusset plate).
 - High volume of traffic because of increased use of the bridge and rush hour.
 - Increased dead load because of previous repairs.
- Insufficient inspection

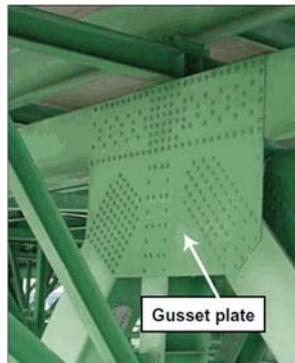
(According to an investigation done by the National Transportation Safety Board, corrosion damage in gusset plates at the L11 nodes, fracture of a floor truss, preexisting cracking, temperature effects, and pier movement were ruled out.)
