STRUCTURAL FAILURES

Hyatt Regency Skywalk Collapse Remembered

By Randall P. Bernhardt, P.E., S.E.

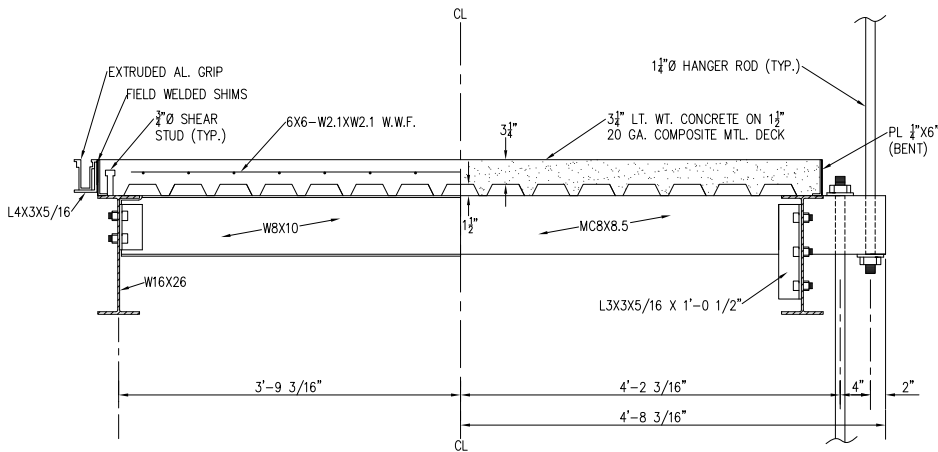
Figure 2. Cross section of the walkway. (Marshall, R.D., et al, 1982. Page 26.)

In the final configuration, the fourth-floor walkway was positioned directly above the second-floor walkway. The third-floor walkway was offset from the other two (*Figure 1*). The distance that the walkways spanned from the tower structure to the conference center was approximately 120 feet. The 120-foot length was split into four equal spans of approximately 30 feet each, using two (2) W16x26 longitudinal stringers per walkway. The ends of the walkways were supported by the tower and conference center structures, but each interior span support consisted of a built-up box beam suspended from the roof structure by two steel hanger rods. The box beams consisted of two MC8x8.5 channels welded toe to toe. The hanger rods were 1¼-inch diameter steel with a yield stress of 36 kips per square inch (ksi) (Marshall et al. 1982). The roughly 8-foot wide walkway was comprised of 3½-inch thick lightweight concrete on 1½-inch steel form deck that spanned longitudinally between W8x10 floor beams (*Figure 2, page 26*).
